TECHNICAL REPORT REMR-CO-3

CASE HISTORIES OF CORPS BREAKWATER
AND JETTY STRUCTURES

Report 5

NORTH ATLANTIC DIVISION

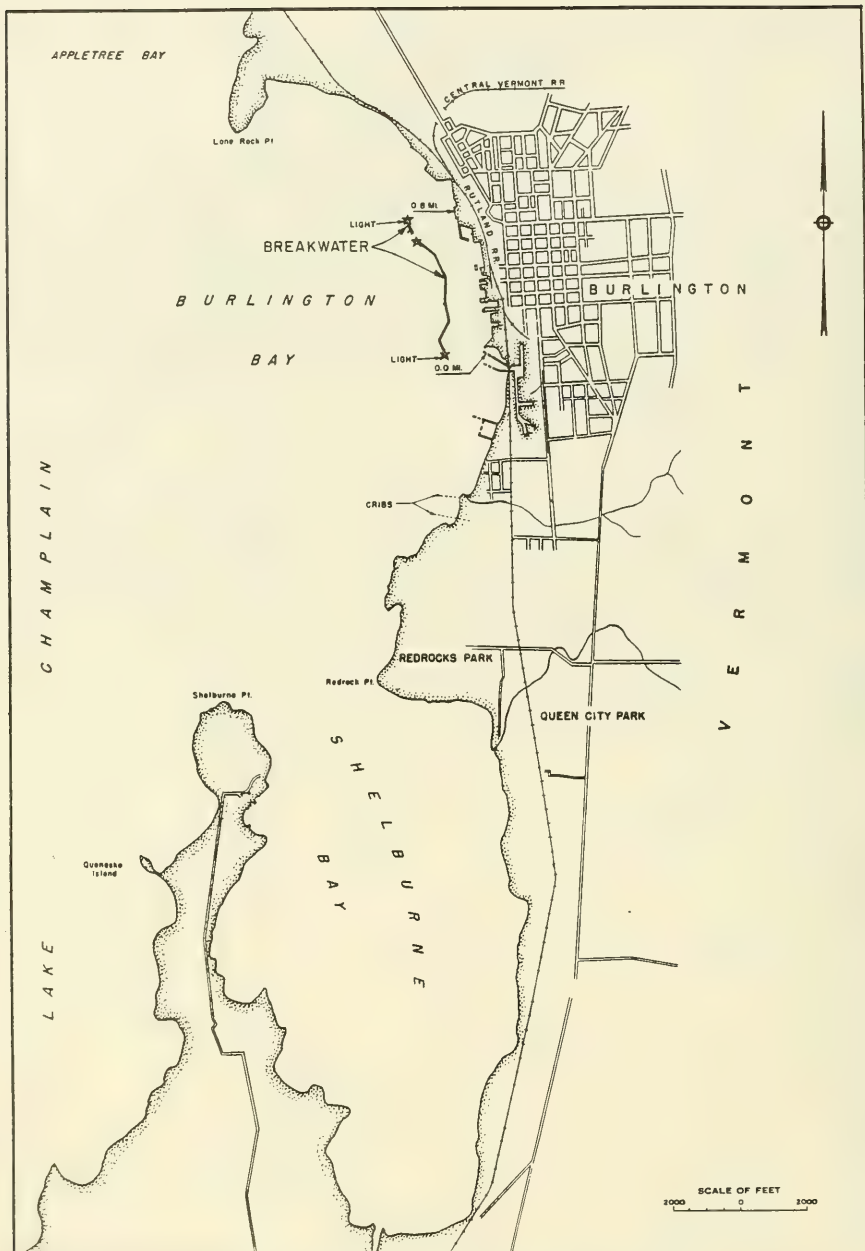
Figure 8. Burlington Harbor, Vermont

<u>Date(s)</u>	<u>Construction and Rehabilitation History</u>
1890	A 4,157-ft breakwater was completed after 54 years of construction (Figure 8). The breakwater consisted of two segments at lengths of 364 ft (north) and 3,793 ft (south) which were separated by 250 ft. Construction was of rubble mound resting on rock-filled timber cribs capped by either concrete (2,457 ft), or rock (1,700 ft). The cribs rested on a sand and gravel bed and were fastened with dowels and tenons. Crest elevation was +8.0 ft low lake level (lll), and crib width ranged from 24 to 34 ft.
1948	The breakwater was repaired. Stone was placed on the lakeside at weakened sections.
1960	A survey indicated the existing structure had settled 1.0 to 3.0 ft along the entire length. Deterioration of sections of the timber fasteners left unconnected sections and caused timber displacement and leaning of the structure lakeward. Deterioration was believed to be caused by wave action and ice conditions over long periods of time. Approximately 550 lin ft of the stone superstructure was undetermined. Eighty feet of the structure was breached.

1962- 1965	The breakwater was rehabilitated using 16,573 tons of stone at a cost of \$381,000.
1986	No further repair or maintenance information has been found.

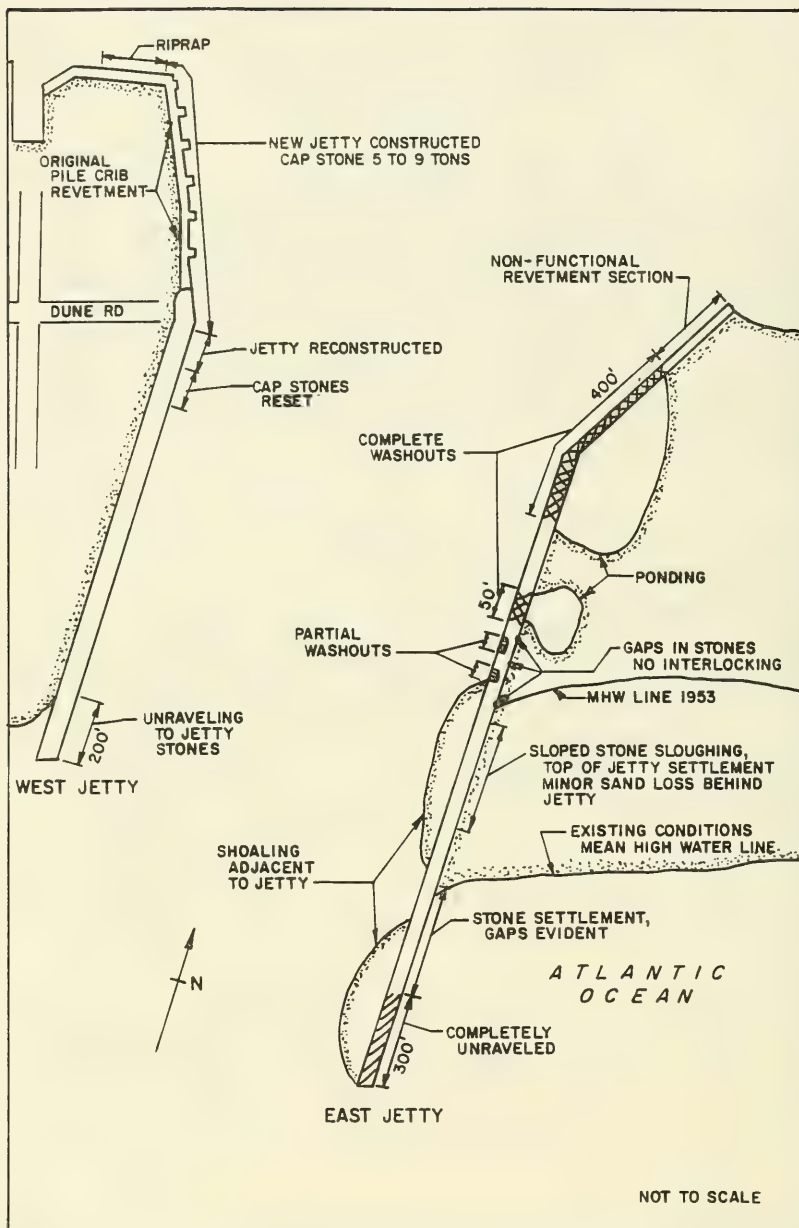
Figure 18. 1982 reconstruction of west jetty and 1985 existing conditions of east jetty, Shinnecock Inlet

1956	A survey revealed that the east jetty had suffered severe damage. Capstones and slope stones had slipped and were disarranged in numerous spots. Core stones were washed out in several places. Capstones and core stones were washed out in four locations totaling 150 ft. The outer 250 ft of the jetty was partly washed out. Beach and dunes adjacent to the jetty eroded, and waves rode over the dunes and flanked the jetty. The west jetty was in fair condition with minor slips and disarrangement in five spots. The inlet was in a shoal condition. Most of the damage was due to a hurricane in 1954.
1982	The west jetty was reconstructed by resetting cap stones to original design geometry over 170 ft. A 1,470-ft-long pile crib revetment on the north end of the west jetty was replaced by a rubble-mound jetty. (Figure 18).
1985	A survey revealed that the reconstructed portion of the west jetty was in good condition. The seaward 200 ft of the west jetty had unraveled and capstones were scattered. The west jetty head had not maintained design configuration. Stones on the inlet side of the east jetty had sloughed in some sections, but stones on the beach side had retained their original position. Two areas on the northern end were completely deteriorated. Erosion of sand caused undermining of the east jetty with continual loss of sand undermining it further.

Date(s)	Construction and Rehabilitation History
1985 (Cont.)	There were areas of partial washouts of stone, settlement, and non-interlocking capstones. The seaward 300 ft was completely unraveled, with all stones scattered (Figure 18). It was determined that the jetties had served their function of inlet stabilization and they were not leaking significant amounts of sand.
1986	Plans call for rehabilitation of the jetties. The east jetty will need new capstones and core stones where there are complete washouts, approximately 450 ft. Original stones will be removed and reset where settlement and sloughing has occurred, approximately 700 ft. The 300-ft east jetty head section will be completely rebuilt with new and original stone. A blanket will be placed for scour protection. A 5.0-ft-thick blanket using 1,000-lb stone will be laid on the existing bottom to prevent additional scouring of the west jetty toe. New capstone and core stone are needed to supplement the displaced stones of the west jetty head. The section will be rebuilt using existing stone but will consist of two layers of armor stone.

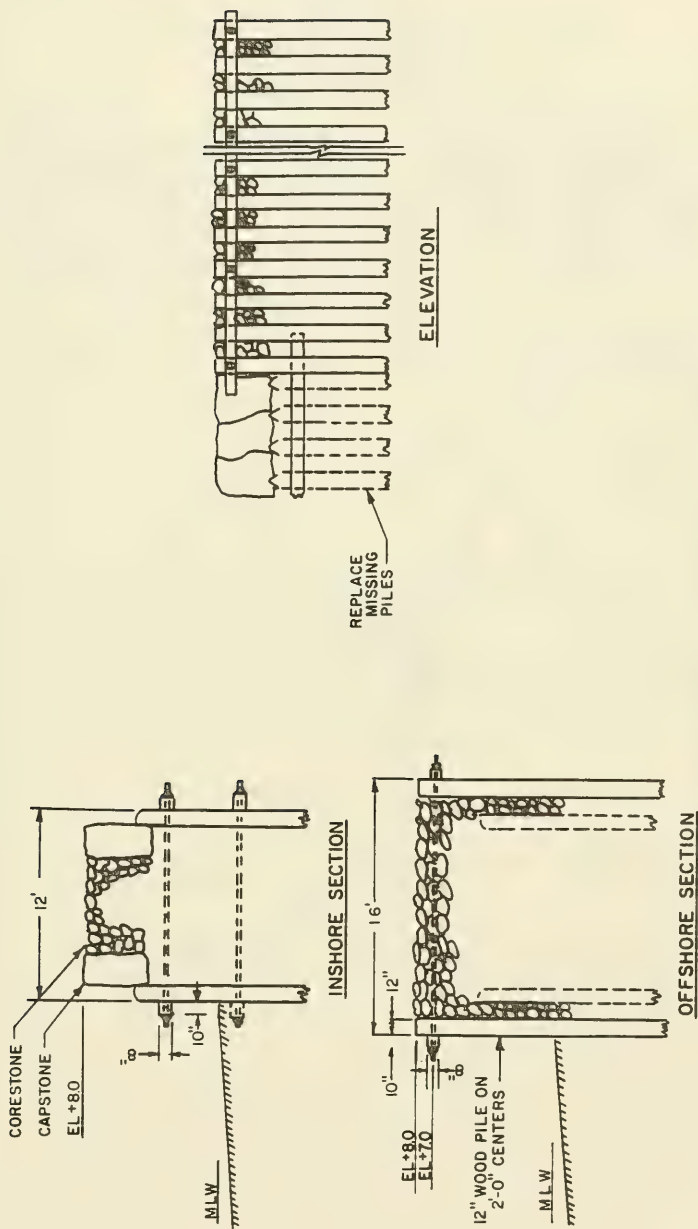
Figure 29. Rehabilitation of Mantua Creek jetties, 1963

<u>Date(s)</u>	<u>Construction and Rehabilitation History</u>
1907	Two jetties were constructed to provide channel protection. Lengths were 754 ft and 580 ft east and west, respectively. The jetties were constructed of stone-filled timber cribs, with mat brush placed to support the stone (Figure 28). Top width and elevation were 12.0 ft and +8.0 ft mlw, respectively, for each jetty.
1912-1913	The east jetty was extended to 1,577 ft, and the west jetty was extended to 1,456 ft (Figure 28).
1918	Repairs were made by the addition of stone.
1962	An investigation of the jetties revealed the jetties had settled an average of 2.0 ft. Approximately 100 ft of the offshore end of the east jetty had deteriorated, with most of the pilings gone, and stone had fallen out to below the waterline. Most of the walings had deteriorated and were missing. Piles were missing at intermediate locations along the jetties, but there was no significant loss of stone at those locations. Piles that remained were in good condition.

1963	The jetties were rehabilitated at a cost of \$136,895. A new row of piles was placed over approximately 100 ft at the offshore ends. Piles were placed 7.5 ft on either side of the center line of the jetties. Corestone was dumped between the piles to an elevation of +8.0 ft mlw (Figure 29). Missing piles were replaced, and new wales were provided along the remainder of the jetties. One row of capstone was placed on the inner sides of both cribs on top of the existing stone to +8.0 ft mlw. Core stone was filled between the capstones in the center of the jetties to +8.0 ft mlw (Figure 29). Crown width was 16.0 ft at the offshore ends and 12.0 ft on the remainder of the jetty. Design wave height was 4.2 ft.
1964	Repairs were made to the seaward end of the east jetty at a cost of \$4,864. The Corps was reimbursed later for this work.
1986	No further repair or maintenance information has been found.

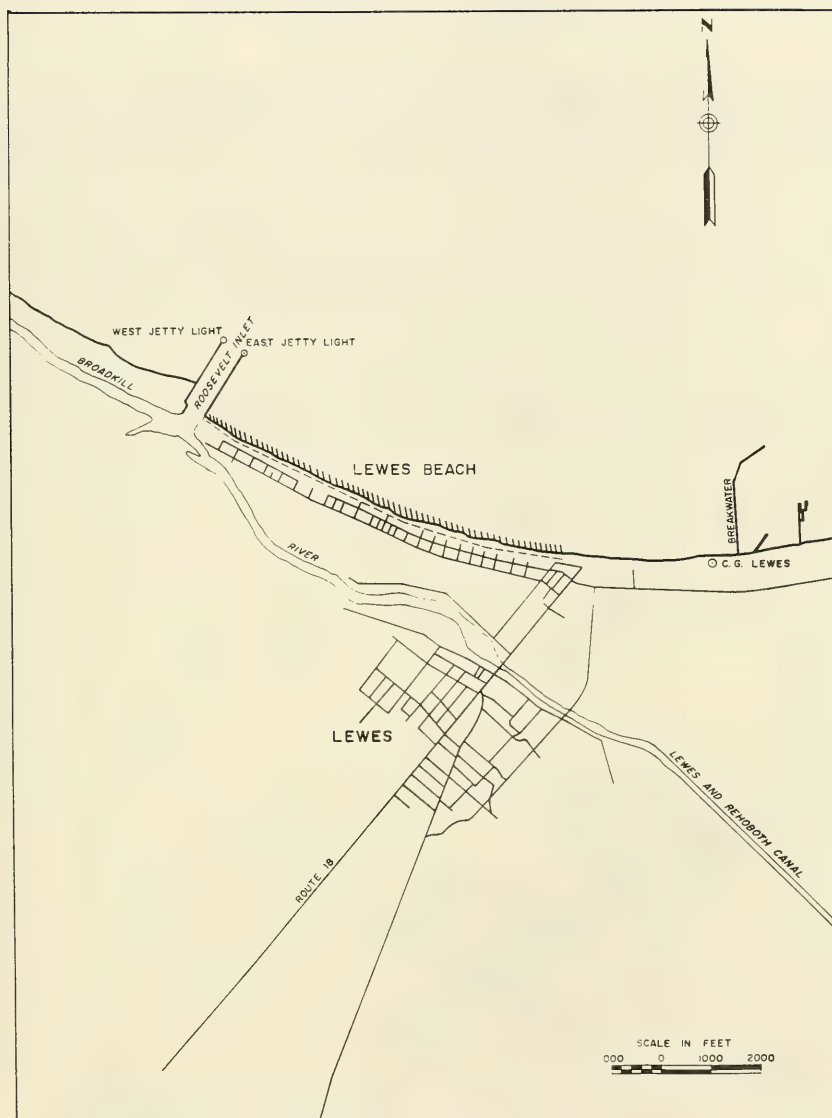
Figure 36. Roosevelt Inlet, Delaware

Date(s)	Construction and Rehabilitation History
1908	A 1,263-ft-long stone-filled timber crib jetty was constructed on the west side of the inlet.
1911- 1914 1917, 1920, 1923	Stone replacement repairs were made each of these years. Cause of damage was due to inadequate jetty design; waves easily damaged the timber cribs. The cribs were also permeable to sand.
1937	The timber crib jetty was replaced by two steel sheet-pile jetties, constructed 500 ft apart, on the east and west sides of the inlet. Both jetties were 1,700 ft long (Figure 36). Crest elevations were +8.0 ft mlw, except the shoreward ends which were +10.0 ft mlw.
1939	The jetties had deteriorated due to corrosion.
1944	The jetties were flanked and rubble was placed along the east bank. The additional rubble extended the east jetty shoreward 400 ft. The possibility of the west jetty becoming completely flanked was determined to be remote; therefore, no rubble was placed on the west bank. Seaward ends of both jetties were repaired due to deterioration by corrosion.

1985	The jetties are in poor condition and are ineffective. They are considered a navigation hazard and are to be removed.

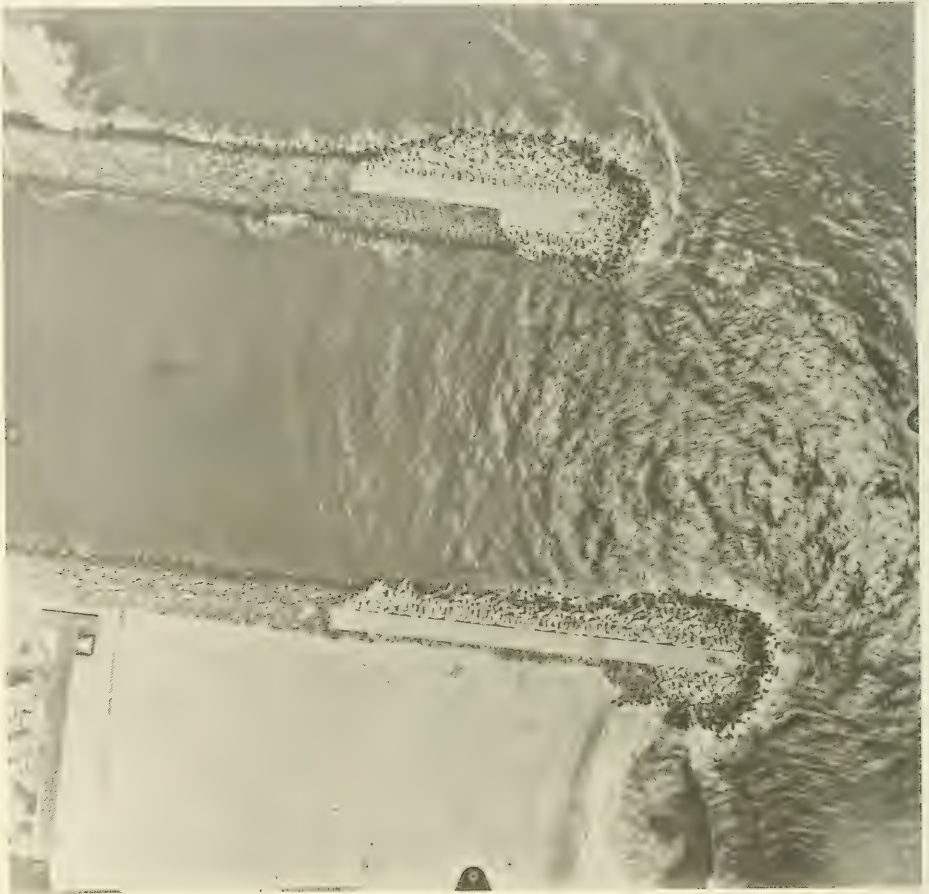
Figure 39. Photograph of Manasquan Inlet jetties
after 1982 rehabilitation

Date(s)	Construction and Rehabilitation History
1979- 1982 (Cont.)	the south side. The seaward 240 ft was concrete capped, 35 ft wide at the seaward end and 20 ft wide elsewhere. Capstone was placed shoreward of the dolosse section, 375 ft on the north side and crest, and 90 ft on the south side. Capstone size decreased in the shoreward direction from 12.0 to 3.0 to 5.0 tons. Design wave height was 25.0 ft. An aerial photograph of the rehabilitation is shown in Figure 39.
1985	The jetties were subjected to several storms after the 1982 rehabilitation, including a design level storm in March 1984. Photogrammetric monitoring of the structures under the Monitoring of Completed Coastal Projects (MCCP) Program indicated the last rehabilitation of the jetties has been fully successful to date.

1955	The north jetty was rehabilitated using 5,400 tons of stone at a cost of \$128,597.
1959	The south jetty was rehabilitated using 12.0-ton capstone at a cost of \$67,048.
1977	The seaward 100 ft and 60 ft of the north and south jetties, respectively, were destroyed through continued displacement of armor stone and loss of structural integrity. The south jetty was damaged from the seaward end to 700 ft shoreward. Sand passed from the south jetty fillet through and over the jetty into the inlet.
1979- 1982	Both jetties were rehabilitated using dolosse. Sand and displaced stone were excavated and reshaped to design configuration before dolosse placement. Sixteen-ton dolosse were placed along the seaward 400 ft on the north side of the south jetty, around the jetty head, and along the seaward 50 ft on the south side. The dolosse extended to -10 ft mlw on the channel side, with side slopes of 1V:2H, and front slopes of 1V:3H. The seaward 400 ft was concrete capped, 20 ft wide, and was built at an elevation of +14 ft mlw. Sixteen-ton dolosse were placed along the seaward 250 ft on the north side of the north jetty, around the jetty head, and along the seaward 90 ft on
